FINAL REPORT

A CONTINUATION OF A PROGRAM OF HIGH ANGULAR RESOLUTION STUDIES OF CELESTIAL X-RAY SOURCES

Contract NASW-1634, Modification No. 1

This document is the final report on NASA Contract NASW-1634, Modification No. 1. This contract is part of a continuing program of X-ray astronomy by AS&E and calls for the refurbishment and reflight of an instrumented payload which was flown under Contract NASW-1634 but due to door malfunctions was not able to obtain useful data on cosmic X-ray sources.

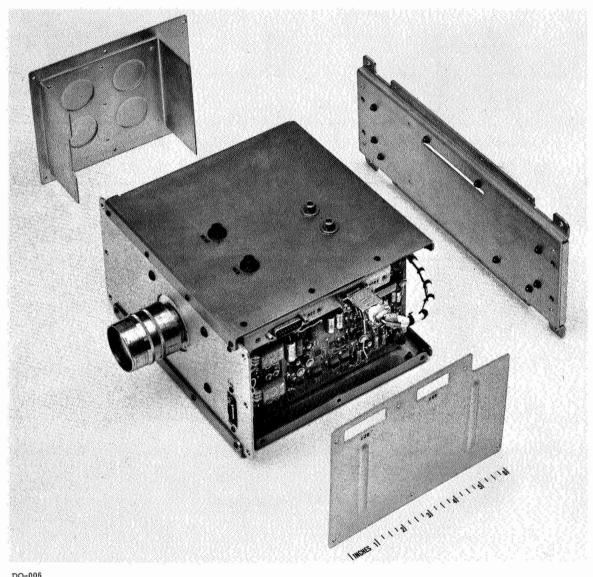
The camera which has now flown satisfactorily four (4) times was a 16 mm Milliken Model DBM-3C with an Angenieux f/.95, 25 mm focal length lens. Figure 1 is a picture of the camera and associated hardware.

ASPECT CAMERA ASSEMBLY

Due to some erratic operation at voltage above 27 VDC, the camera has been sent back to the factory for a complete overhaul in anticipation for further flights.

A new film which is twice as sensitive as film used previously was tested and installed on this flight. The film is Kodak 2485 High Speed Recording Film with an ESTAR-AH base.

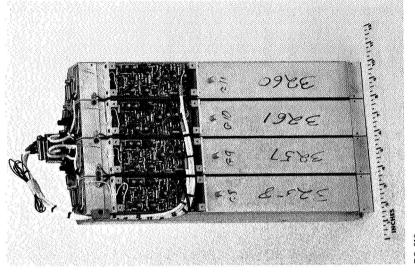
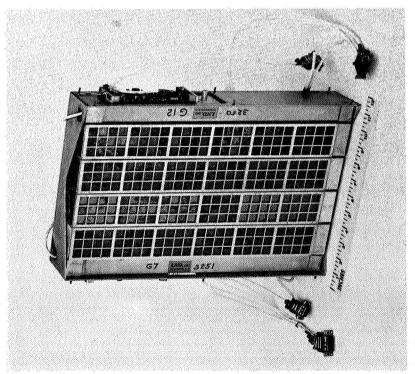
PROPORTIONAL COUNTER ASSEMBLIES

structure. The thick window (guard) counters were filled with Xenon and had overall dimensions of 16" x 2" x 1". The counters were set up in two banks with 4 active counters in front, enclosed by 6 guard counters on 3 sides in each bank. Figure 2 shows the layout of an active counter bank with a guard counter on each side. Figure 2 also shows the layout of the remaining guard counters which are mounted directly behind the active counters. Location of the preamp for each proportional counter can also be seen.

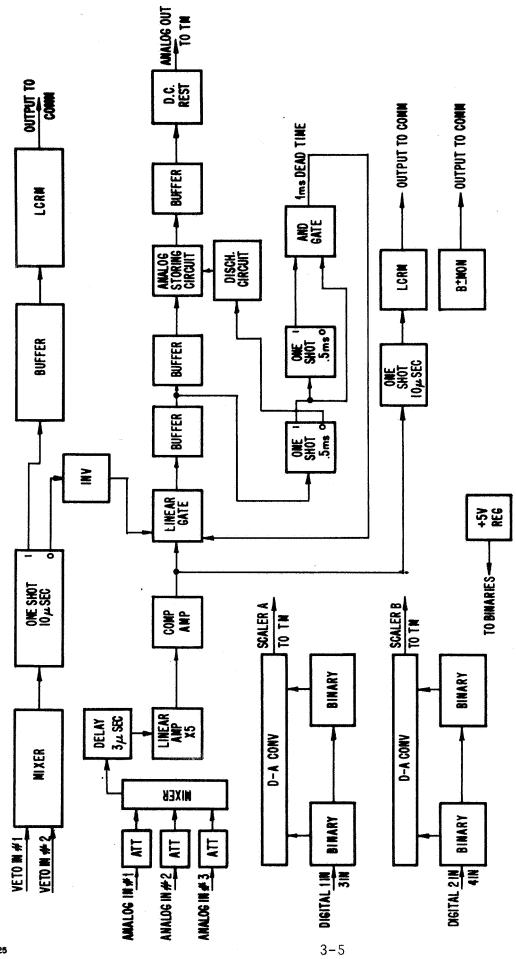
Any cosmic ray event which was able to penetrate the active counters and reach the guard counters would produce a veto signal which would block out the corresponding signals generated in the active counters. A 3µs delay line was added to the logic circuitry to compensate for any delays which might occur in the development of the veto signal in the guard counters. Figure 3 is a block diagram of the proportional counter logic used. Digital information was supplied by each active counter, and two active counters were combined for the pulse height information. Two scalers, one pulse height analog channel and two log count rate meter outputs were supplied by each of four separate logic circuits. Figure 4 is a block diagram of the preamp circuit used for each of the counters.

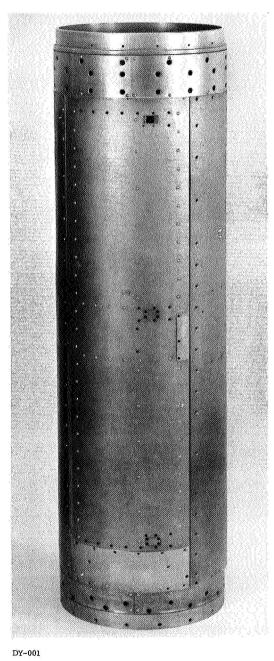
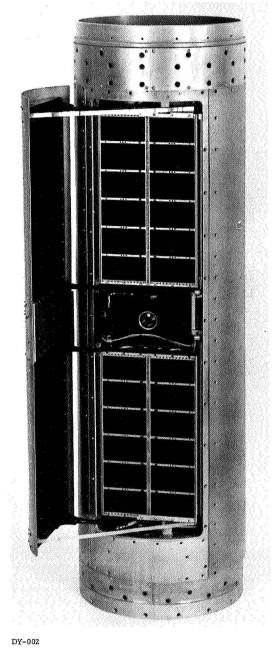
Figure 5

Two slat-type collimators, one in front of each bank of counters, were used to limit the acceptance directions of the X-rays to a field of view of 2° x 45° (full width half maximum). The two sets of slats were inclined $+30^{\circ}$ and -30° from a plane normal to the roll axis of the rocket. The overall dimension of each collimator bank was $15" \times 8 \frac{1}{2"} \times 5 \frac{1}{2"}$. The individual slats were made of iron and spaced a distance of .160". The collimators and their relation to the camera are seen in the fully assembled payload shown in Figure 5. A closeup view of the collimators is shown in Figure 6.

VIEWS OF ASSEMBLED PAYLOAD

CLOSED

OPEN

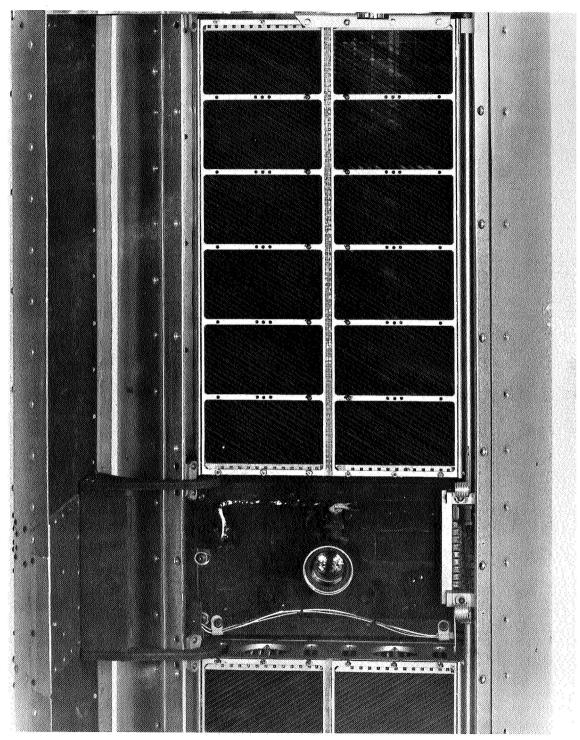
Figure 6

CLOSE-UP OF COLLIMATOR IN ASSEMBLED PAYLOAD

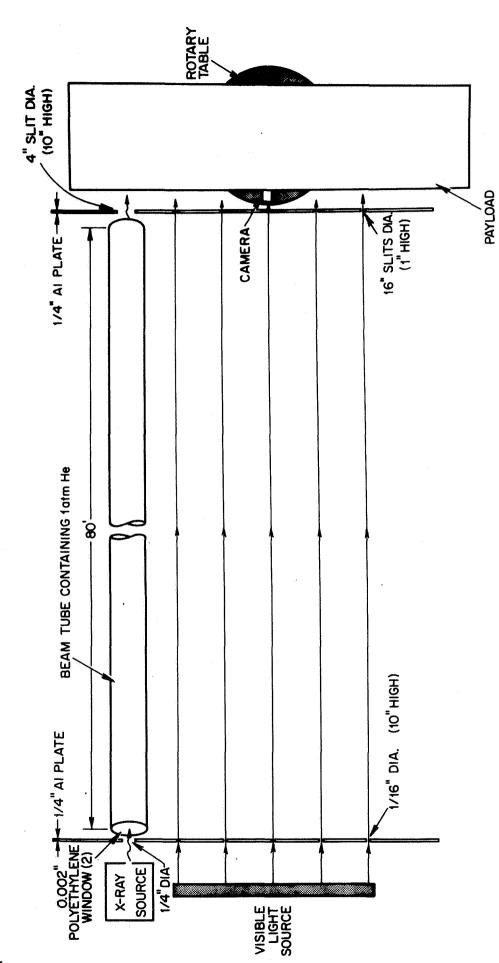
The rigidity of the payload was such that the alignment of the aspect camera and the X-ray collimators would be maintained throughout the launch and duration of the flight. However, it was essential to measure their relative alignment in the laboratory prior to flight. Through knowledge of the alignment, the location of an X-ray source could be determined from the observance of a counting rate peak at a certain time and the aspect photographs. This was achieved by setting up an "X-ray" star in the laboratory. Several light beams and an X-ray beam were made parallel to each other by collimating each through the same two rigid plates. The entire payload was set upon a rotary table with both the aspect camera and X-ray detectors in operation, as shown in Figure 7. The payload is positioned such that the camera views one of the light beams. As the rotary table is turned, a maximum is observed in the counting rate. At exactly that point a photograph is taken. Inspection of the photograph reveals where on the photograph the X-ray star will appear. The camera registration was sufficiently precise, such that the sprocket holes of the film could be used as a reference. This technique enabled us to establish the alignment to within several arc minutes.

Collimator plate #1 consisted of a series of holes (1/4" dia for X-ray, 1/16" dia for visible light), spaced 3" apart. Collimator plate #2 was a

MEASUREMENT OF CAMERA-COLLIMATOR ALIGNMENT

series of slits 1" high whose spacing matched that of plate #1. It contained a 4" opening for the X-rays and several 1/16" openings for the light.

The X-ray and light sources were removed 80' from the payload. Consequently, the X-ray beam was collimated to 17 arc min. by the 4" opening and the light beams were collimated to less than 1/2 arc min. Several passes were needed to sample the entire 32" of collimator length. As the low energy X-ray flux would be utterly attenuated by 80' of air, a beam tube containing 1 atmosphere of helium was used between the plates as the means of transmitting the X-rays.
